Forensic Investigation of Personal Injury Cases

An overview of the approach and benefits with detailed case studies

CPD Conference - 13 October 2022 – Lingfield Park Resort

Ian Major MEng CEng MICE

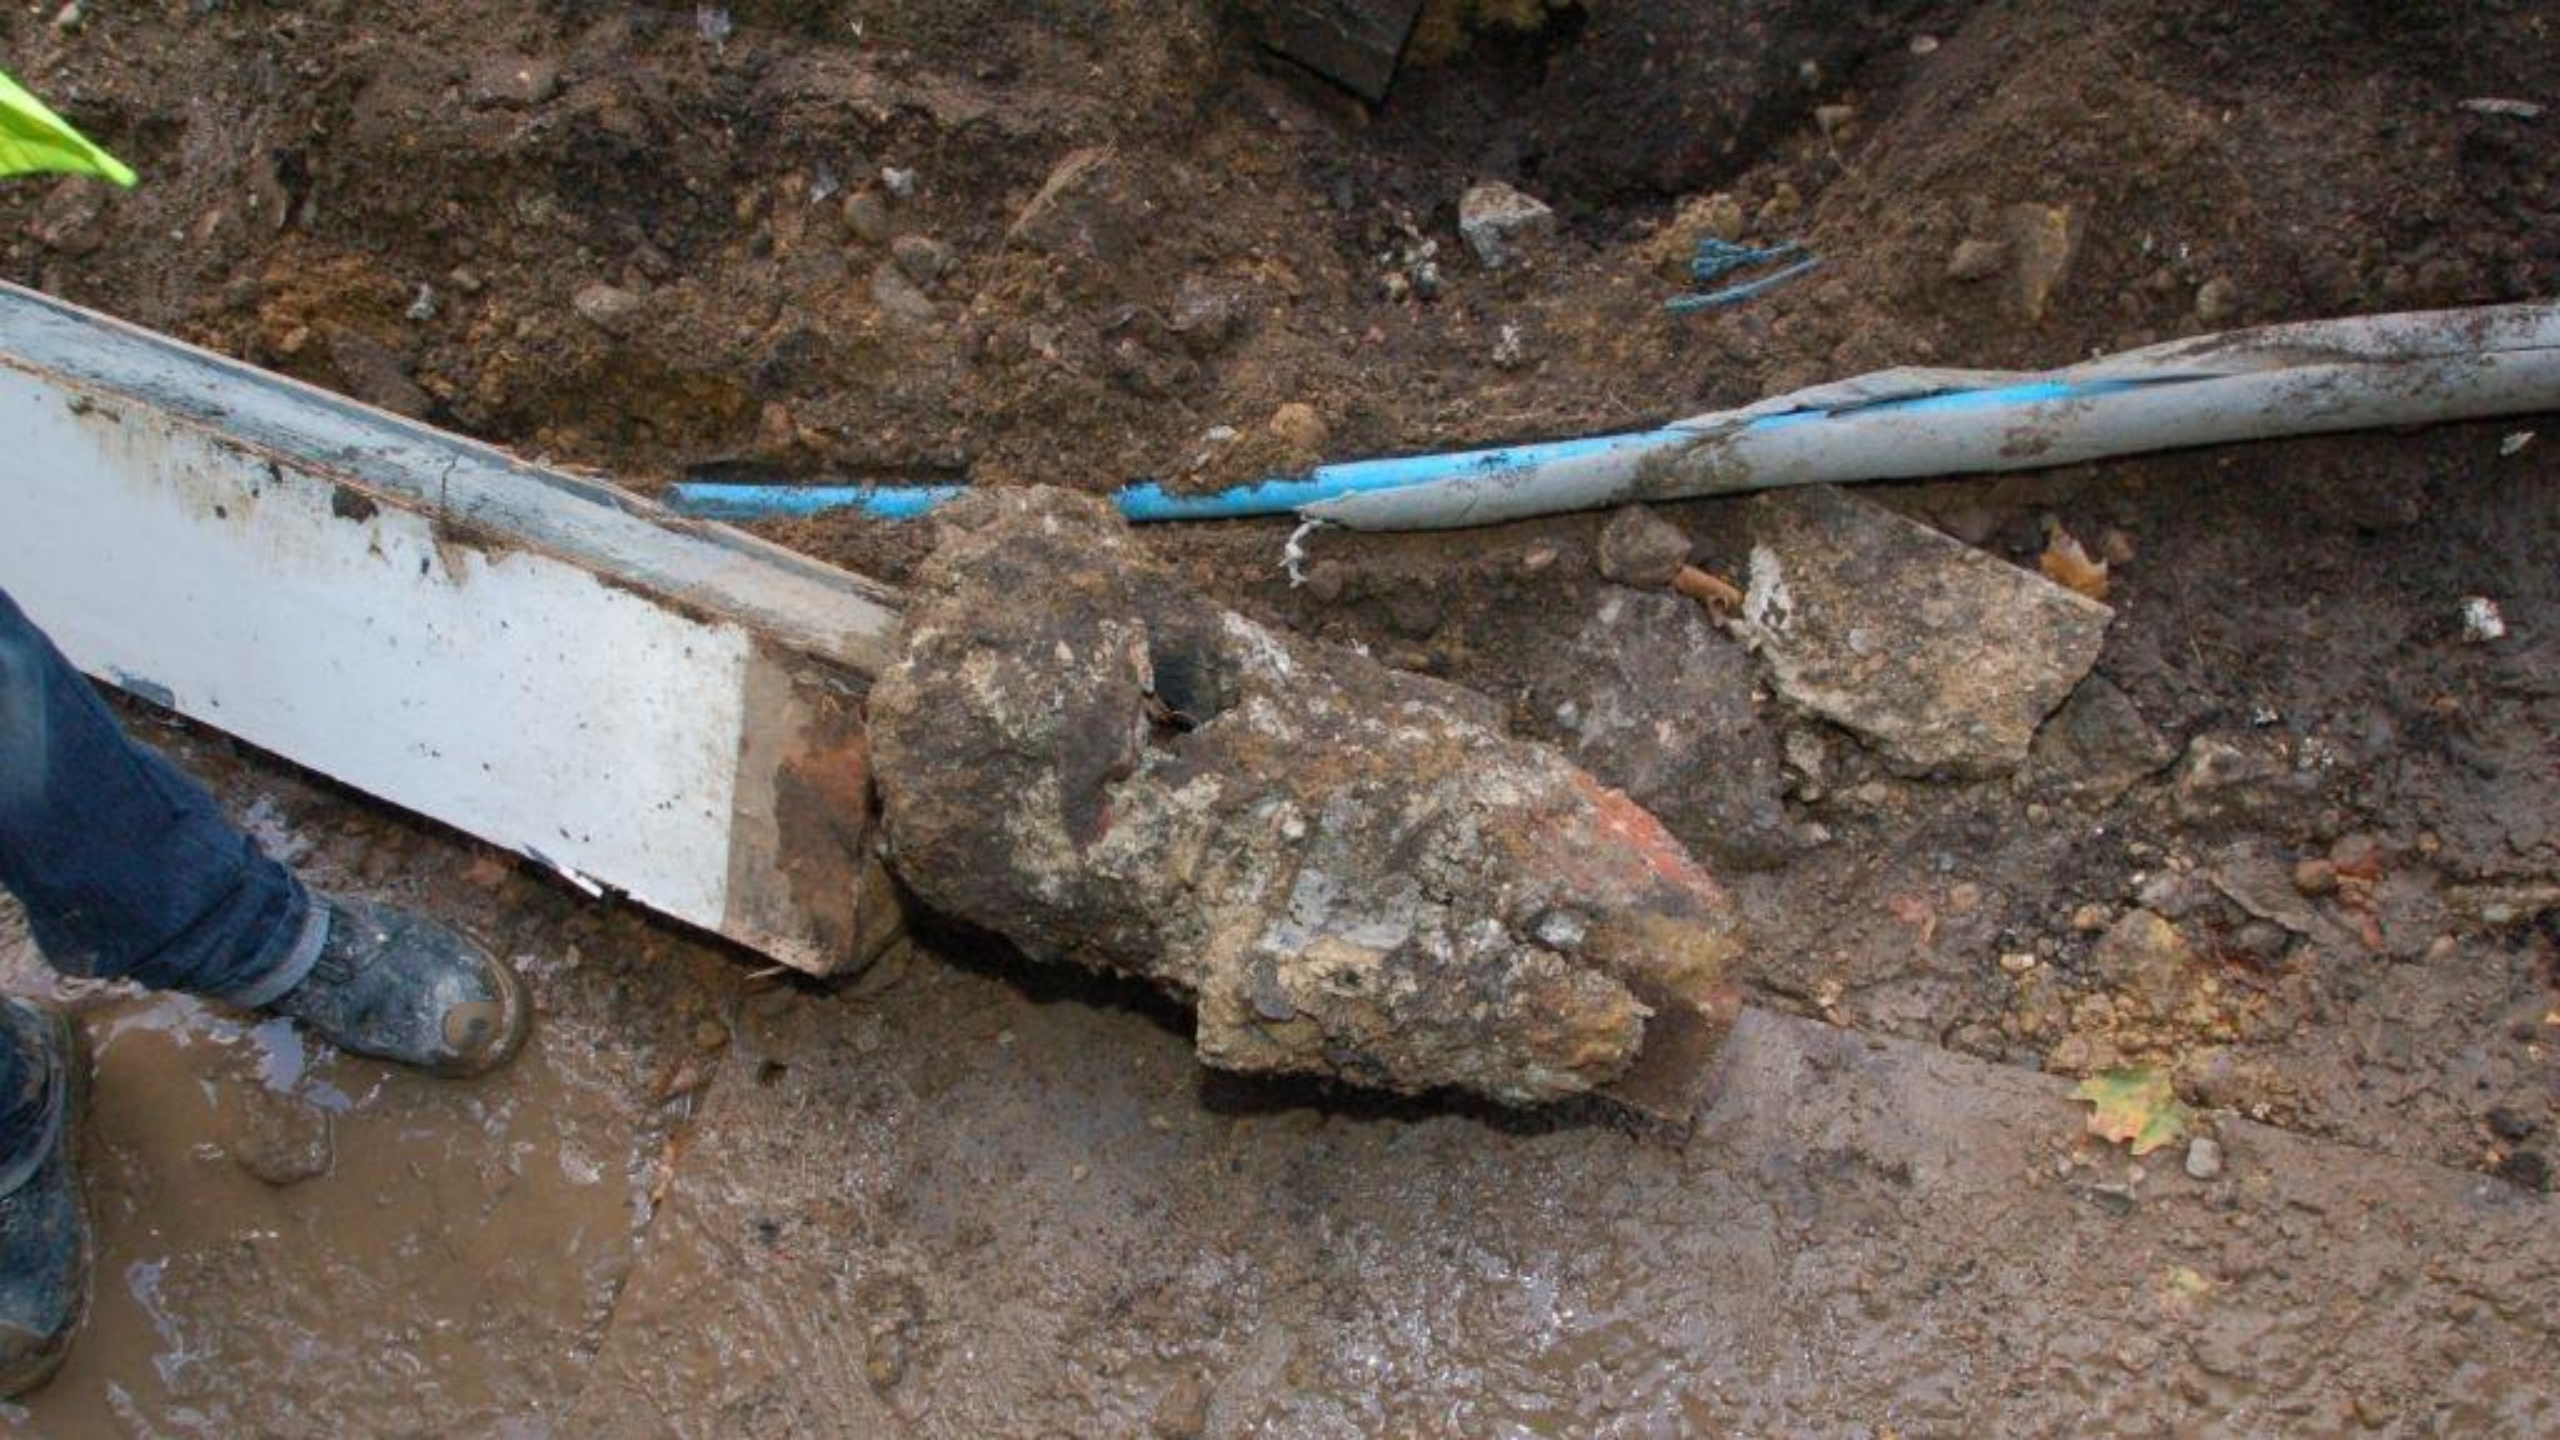
Weather review

- Wind speeds of 30 to 40mph in most months
- Wind speed >50mph on 5 occasions

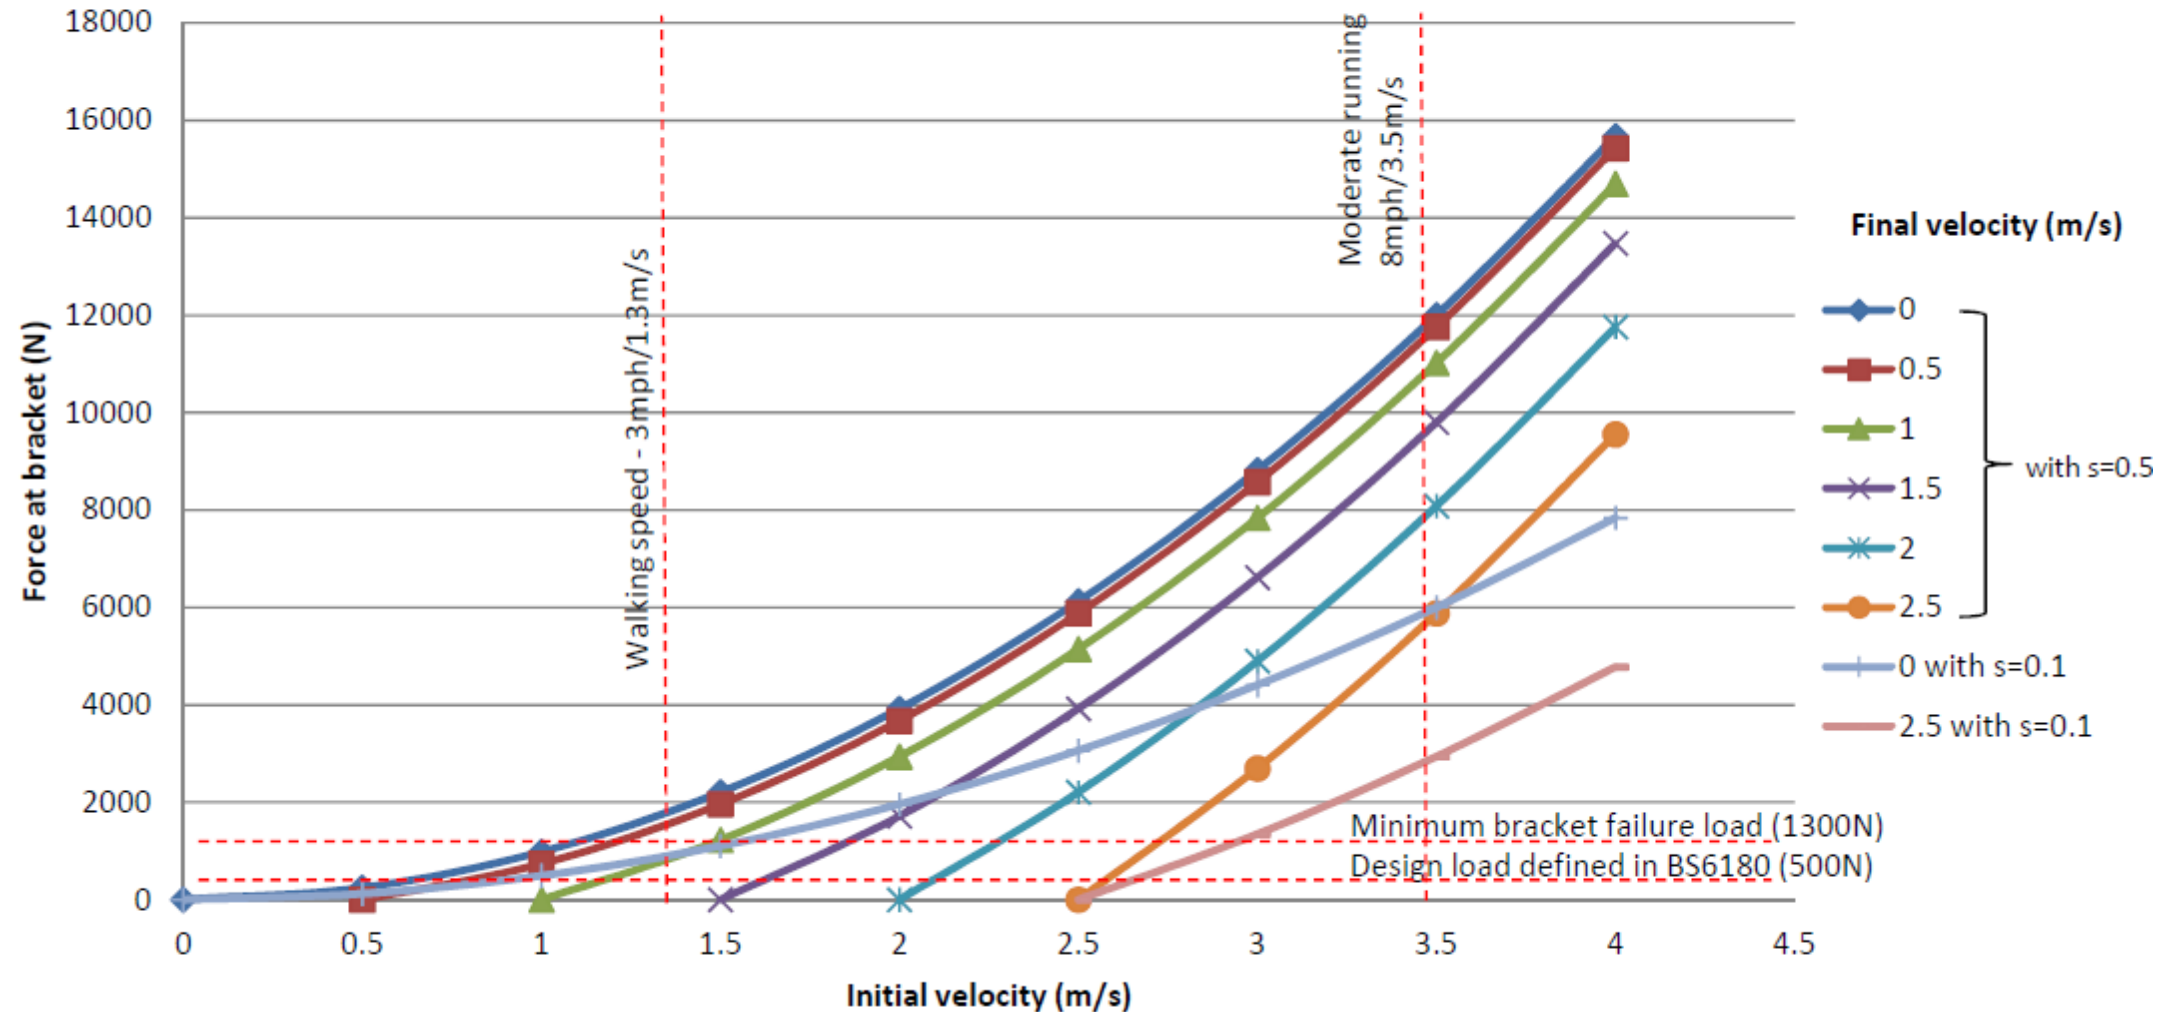
Results

Variation of the force at the bracket with velocity
(combined mass = 140kg)

- Window was suitable as a guard
- Load capacity was well in excess of British Standard requirements
- No evidence of poor installation
- Analysis demonstrated plausible explanation for excessive load
- HSE dropped the case

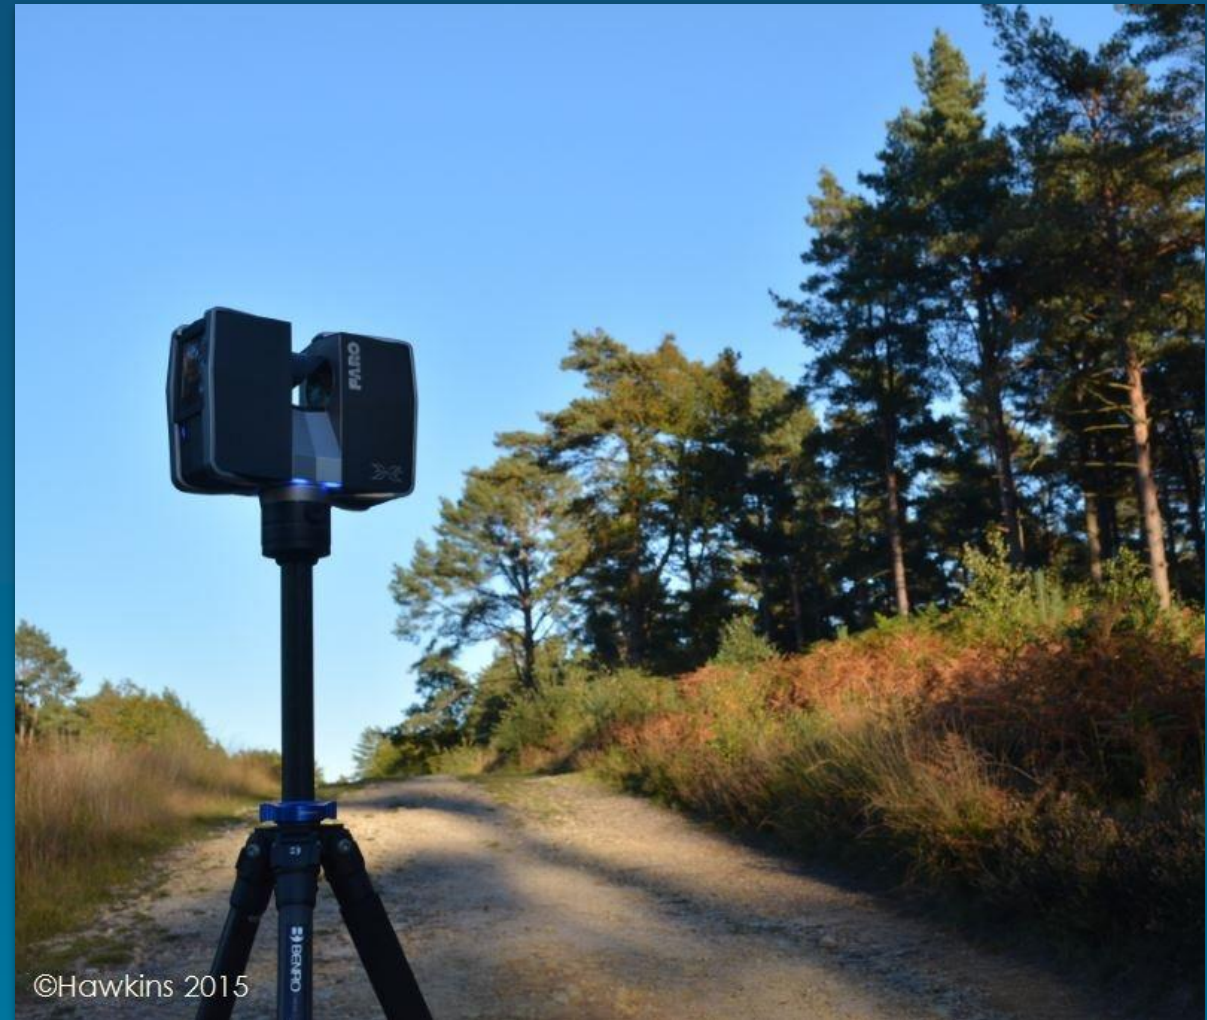
3D model – fall from wall
